FAKULTET TEHNIČKIH NAUKA UNIVERZITETA NOVI SAD  
SPECIALISTIČKE STUDIJE "ENERGETSKA EPIKASNOST"

**SAVREMENE METODOLOGIJE DETEKCIJE  
ENERGETSKIH GUBITAKA OBJEKATA URBANIH  
SREDINA**

II dio - Termalno snimanje

Prof. Dr Tosa Ninkov dipl.inz  
Doc. Dr. Vladimir Bulatovic dipl. inz  
2011/2012

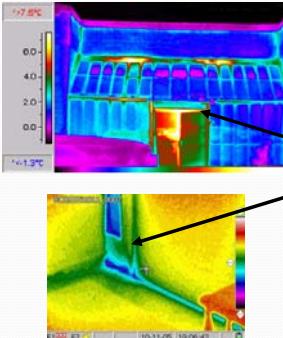
When conditions are right, it is possible to locate missing or damaged insulation, such as this poorly insulated area over a patio door

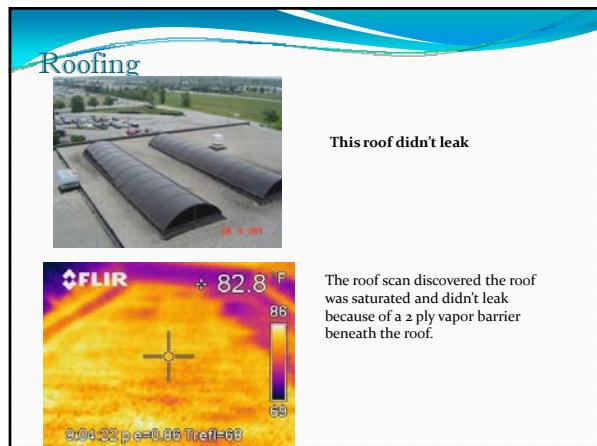
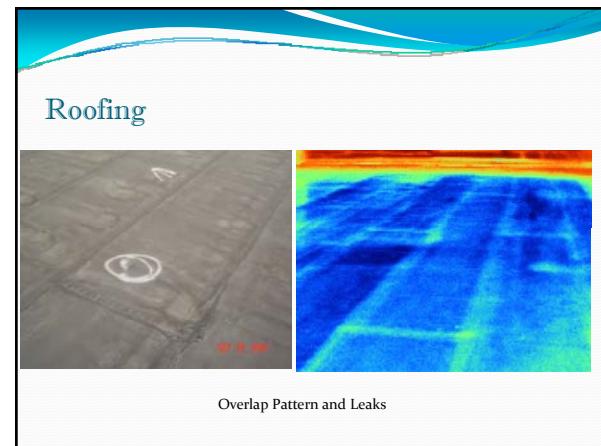
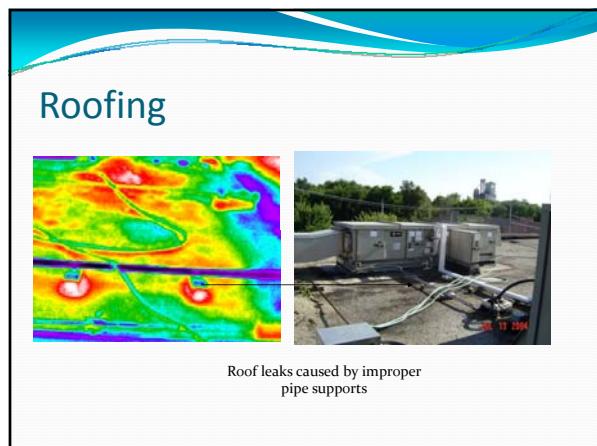
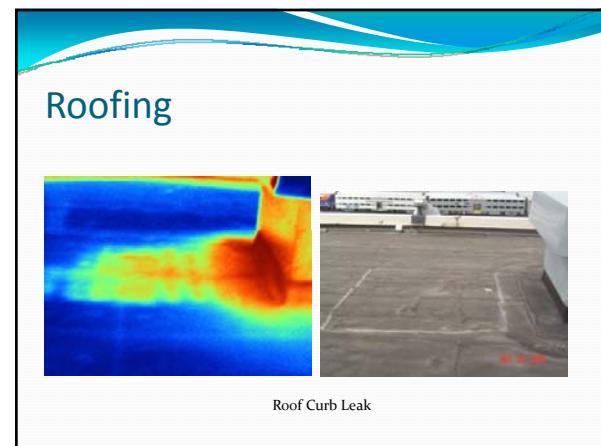
**Detekcija gubitaka preko krovova**

Detekcija energetskih gubitaka preko krovova omogućava izrađu optimalnim projekata sanacije kojom se smanjuju gubici a i smanjuju proškovi rekonstrukcije

Problemi na detekciji lokacije energetskih gubitaka i pronađenje optimalnog resenja rehabilitacije krova se resavaju multi disciplinarnim pristupom analizi podataka sadrzanih na infrared snimku ( Infrared snimatelj, gradjevinski inženjer, arhitekta,...)

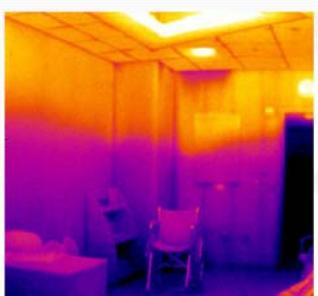
Poor circulation of air is shown in this room. Notice the warm air at the top of the room and the cool floors, blue. Commonly referred to as the "Stack Effect".
