Leica Geosystems **TruStory**

Automated Deformation Monitoring

Apollo Bridge, Bratislava, Slovakia

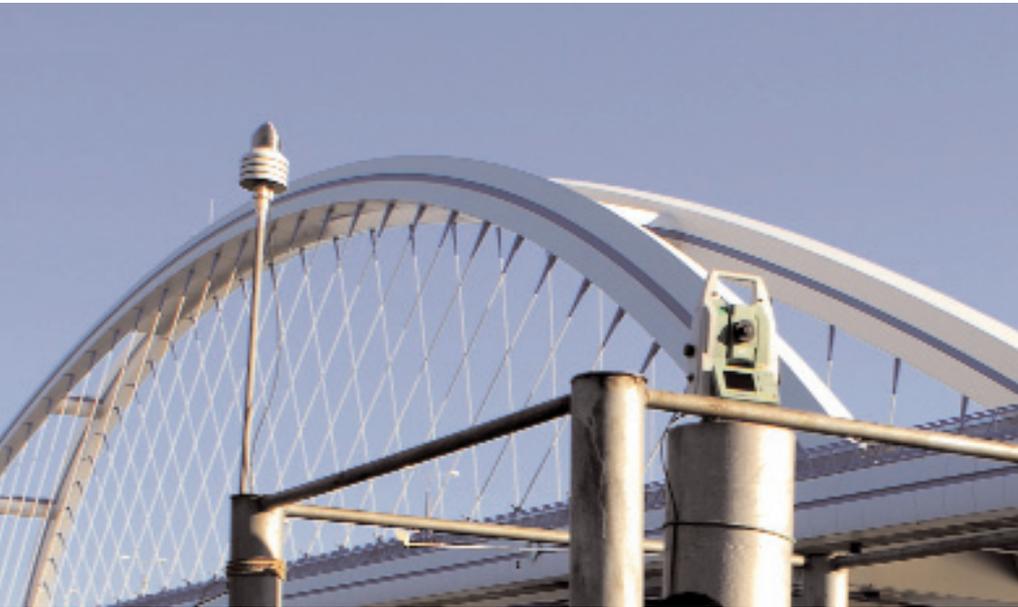
The Apollo Bridge is one of five road bridges across the Danube in Bratislava, connecting the centre of the city with the district Petržalka. The traffic load and temperature changes cause deformation of the bridge structure. In addition, the use of the developed automated measurement system (AMS) for long term monitoring allows the Department of Surveying of the STU Bratislava to determine actual information about the deformation of the main structure in real time. The AMS consists of the Leica TS30 high-precision total station with Automated Target Recognition (ATR), a Leica Viva GS15 and GPS1200+ GNSS receiver, and a Leica Nivel 220 inclination sensors as well as accelerometers.

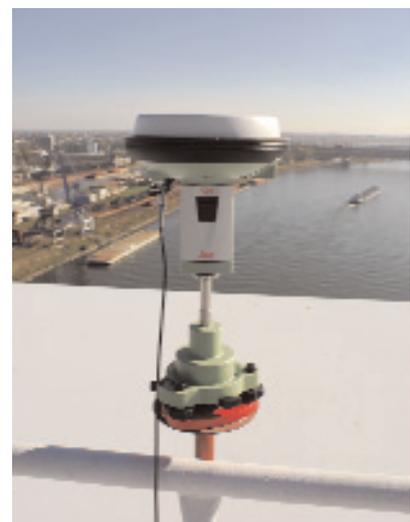
Leica Viva GS15 GNSS receiver on top of the bridge arch.

The GNSS Leica Viva GS15 was to static mode measurement and receiving data at an update rate of 1 Hz was used to determine the horizontal displacement of the top arch. All the data was stored in the internal receiver's memory (SD memory card). The Leica Nivel220 inclinometers, registered with 1 Hz frequency were used to determine the longitudinal and cross inclination of the bridge. The vibration of the bridge deck was monitored by one-axial accelerometers HBM B12/200 (in vertical direction) with a sample rate of 10 Hz.
